PASSAIC RIVER BASIN

GREEN SWAMP NO. I

PHASE I INSPECTION REPORT
NATIONAL DAM SAFETY PROGRAM

NJ 00209

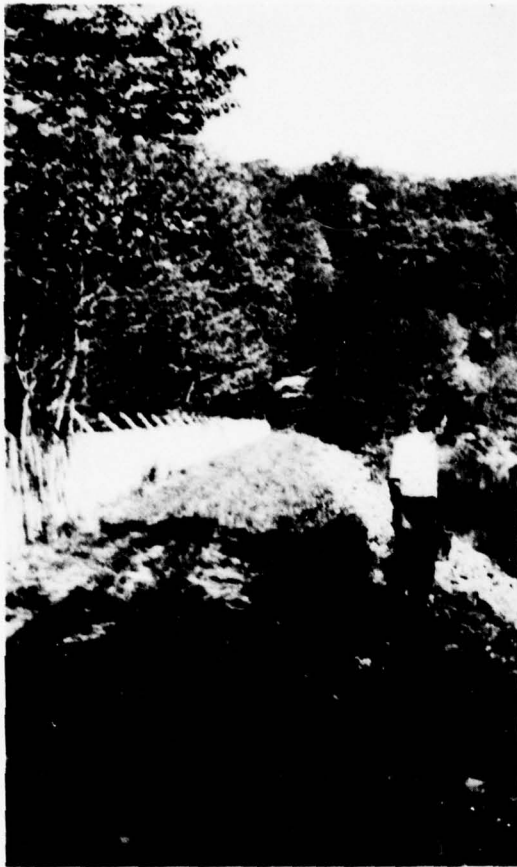
LOOKING WEST ALONG CREST

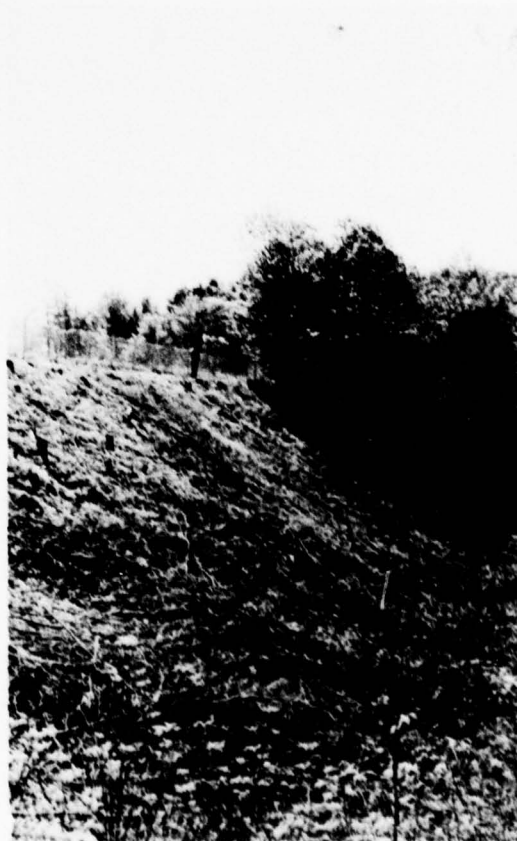
PARTIALLY CLEARED DOWNSTREAM
SLOPE LOOKING TOWARDS LEFT ABUTMENT

7.2.2 Operational/Maintenance Procedures: Clearing and prevention of tree growth on the east side of the downstream embankment should be continued. The cleared embankment slope should be redressed and seeded with selected grass.
